QUALITY CRITERIA FOR INSTALLED INSULATING GLASS UNITS (IGUs)

This observation guide has been produced to help answer many of the common questions which arise once glazing has been installed.

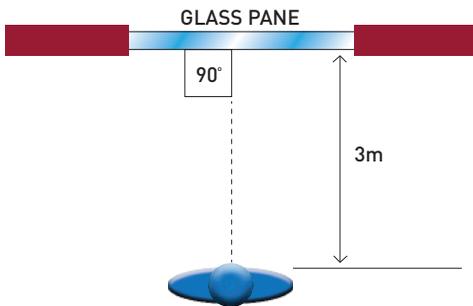
Look at the glass in a vertical plane and at right angles (90°) to the glass surface from the room side. Stand, where possible, 3m away from the unit to be inspected. Do this in natural daylight – but not in direct sunlight – and when the glass is completely dry.

In a visual observation you look through the glass, not at it. Any defects should be identified within 20 seconds. If the defect is not visible at the specified distance, or it takes longer than the time limit to identify, it is regarded as neither obtrusive nor visually disturbing.

Magnifying devices and strong light sources are not permitted during the observation. All defects must **first** be identified at a distance of 3m and not within a closer range.

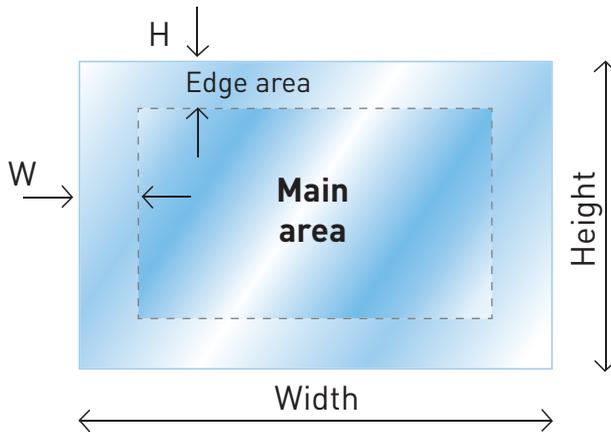
Definition of observation areas

$H = 5\%$ of Height or 50mm whichever is the greater
 $W = 5\%$ of Width or 50mm whichever is the greater

These include bubbles (gaseous inclusions), stones and “seeds”; and are evaluated by identifying the quantity and size of the inclusions. Limits as per the chart below;

Dimension of nuclei of spot faults in mm	Area of pane less than 5m ²
Less than 0.5mm	No limitation
Between 0.5 and 1mm	1
Larger than 1mm	Not allowed

Spots and pinholes in the glass coatings must be measured and counted. Limits as per the chart below;

Dimension of punctual defect - spots/pinholes	Main area & edge area*
Less than 2mm	No limitation
Between 2mm and 3mm	Allowed if not more than 1 per m ²
More than 3mm	Not allowed

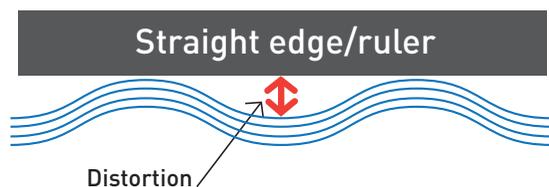
The toughening furnace rollers may also cause a slight unevenness in the glass surface.

Glass Type	Maximum Distortion Value
Float Glass to BS EN 572-2	0.3mm per 300mm
Others	0.5mm per 300mm
